## Identifying aging and installation issues in an HV bushing

## CASE STUDY

## Identifying aging and installation issues in an HV bushing – Analysis with 1 and 500 Hz PF

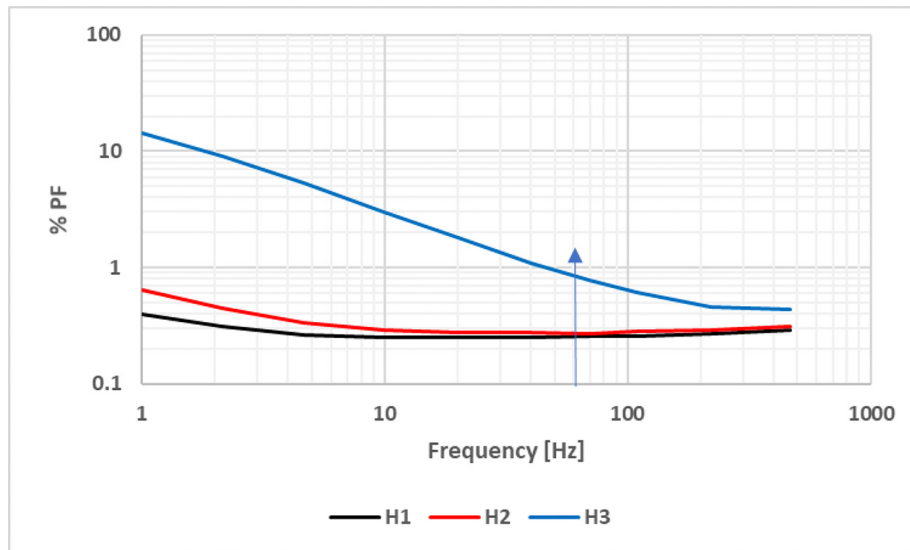
Figure 1: NB DFR measured test results for the high-side 69 kV bushings

- Given the LF PF test results, the utility performed NB DFR tests on the high-side bushings. 1 Hz and 505 Hz measurements from this testing are provided in Table 2. These tabular results affirm the good condition and rating of bushings H1 and H2 but escalate the assessment of the H3 bushing to an investigate rating.

NB DFR test results for bushing H3 (the blue trace in Figure 1) revealed the following two worrisome electrical characteristics and the utility replaced the bushing.

- A bushing in good condition will have an ITC temperature-corrected PF value  $\leq 1\%$  at 1 Hz. The ITC temperature-corrected 1 Hz PF test result of bushing H3 was 7.92 % (Table 2).
- The 10 kV LF PF test result, 1.1 % (Table 2), and the LF PF test result at 250 V, a typical NB DFR test voltage, taken from Figure 1, 0.8 %, are different. This implies a voltage dependence of the LF PF test results.

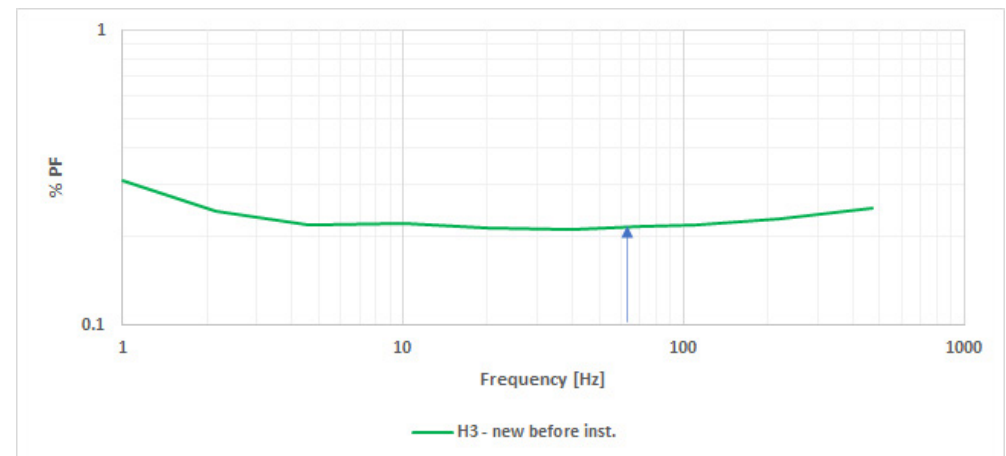
Figure 2: Pre-installation NB DFR test results for H3 replacement bushing

- Before installing in the transformer, LF PF and NB DFR testing was performed on the H3 replacement bushing to confirm its integrity. LF PF and NB DFR test results indicated the bushing's good (G) condition (Table 3) (Figure 2).

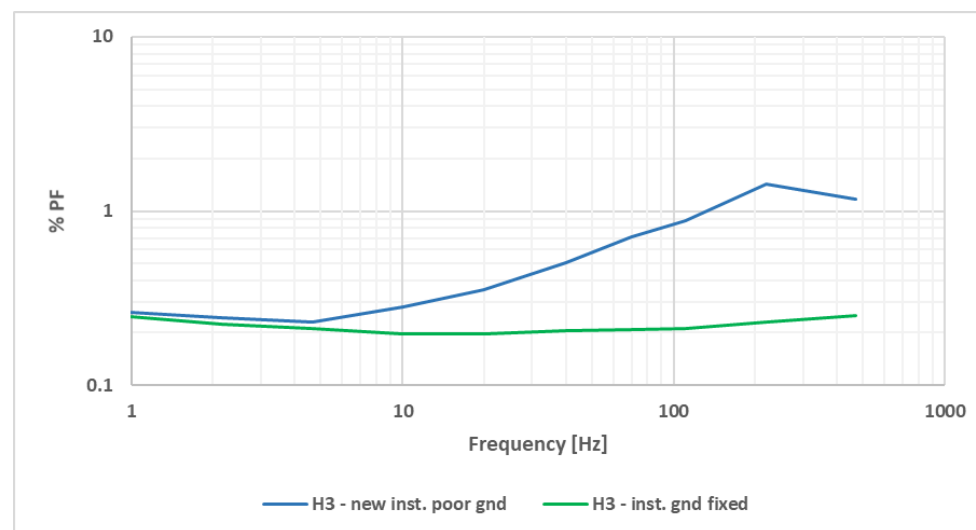
Figure 3: Ground effect on the NB DFR test results of H3 replacement bushing

- The 10 kV measured LF PF test result for the H3 replacement bushing was acceptable. However, the ITC temperature-corrected LF PF result is ~ 1.5 times the measured value while the 1 Hz measured and ITC temperature-corrected results are nearly the same and the 505 Hz PF test result is both non-typical and notably higher than the 505 Hz PF test results for the H1 and H2 bushings.

- NB DFR tests for the installed H3 replacement bushing revealed a non-typical response, with uncharacteristically high losses in the high frequency range (blue curve in Figure 3).

- The data implicated the connection integrity of the bushing flange to the grounded tank. To verify the suspected grounding problem, the testing specialist applied a ground strap to the bushing flange and repeated the LF PF and NB DFR tests (Table 6). A significant improvement was observed in the LF PF test results and the dielectric response with the ground strap in use (green curve in Figure 3).

- It should be noted that the field test specialist had no prior experience with detecting poor flange grounding. When presented with the probable cause of this 505 Hz anomaly, the specialist used a multimeter and measured the resistance between the tank ground and bushing flange with no notice of a resistance issue. Only with the use of a four-terminal low resistance test instrument was the specialist able to detect a 'before and after' difference. This underscores the exceptional sensitivity of a NB DFR test to insufficient bushing grounding.

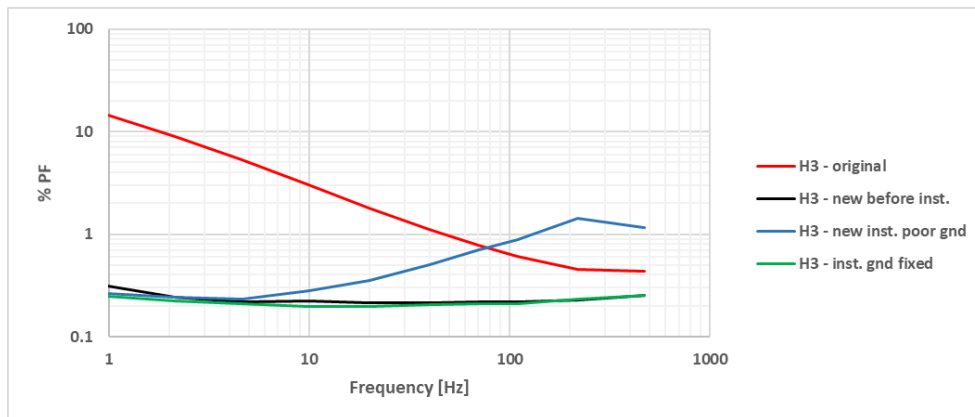
Figure 5: H3 bushing NB DFR test curves from 'as found' to 'as left'

- The NB DFR curves of the original H3 bushing, the H3 replacement bushing before installation, after installation with poor grounding, and finally in its 'as left' condition after restoring a good ground connection are shown in Figure 5. This provides a striking visual reminder of how bad the original bushing was, how practical NB DFR is for post-installation verification, and what the DFR curve for a bushing in good condition should look like.
