Misleading line frequency insulation results on a contaminated transformer

CASE STUDY

A 1978 vintage, 20 MVA, 69/13.09 kV, Dyn1 transformer, operating for a major North American utility, was taken out of service to repair a pump in the cooling system. The technical maintenance team completed the required repairs and conducted a complete protocol of routine commissioning tests, including a 10 kV line frequency (LF) power factor (PF) test.

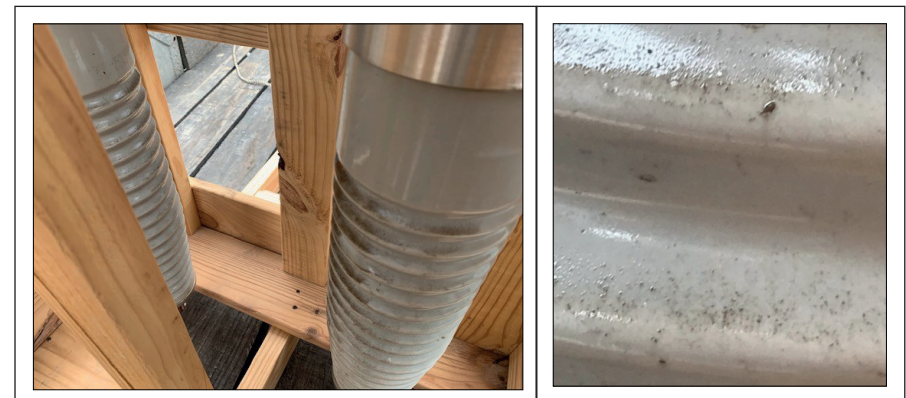
- Not surprisingly, the 1 Hz PF test results confirmed the need to investigate all HV bushings.
- The asset owner ultimately decided to replace the HV bushings.
- The transformer oil was drained and the HV bushings were removed from the unit. Figure 4 shows a layer of contamination on the bottom section of the bushings.

Figure 4: HV bushing removed from the transformer – surface contamination on its lower insulator

- Based on these findings, the owner decided to filter the oil to ensure the removal of all in-tank particulates.
- New bushings were installed and tested. Excellent LF (Figure 5) and 1 Hz PF (Figure 6) values were obtained. Test conditions were:
 - Ambient temperature (TA) = 12 °C
 - Transformer top oil temperature (TOT) = 37 °C
 - Bushing temperature (Tavg = (TA + TOT)/2) = 24.5 °C

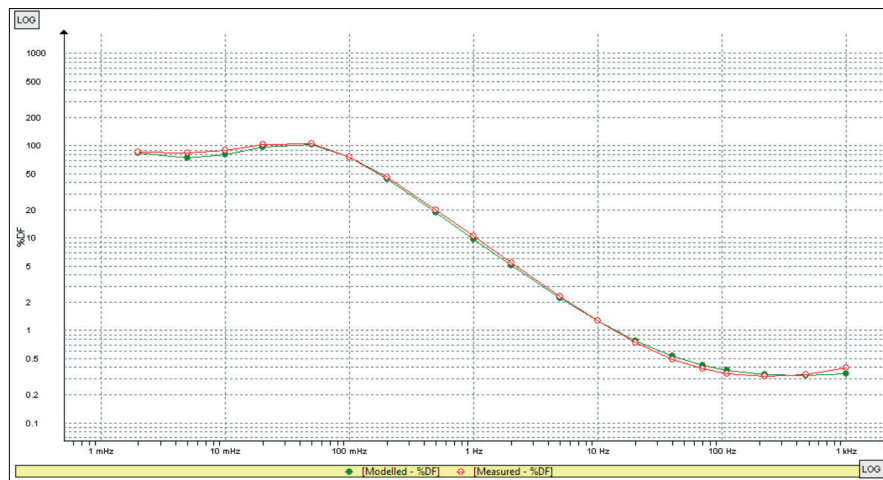
Figure 9: Dielectric Response after oil processing

- Full-spectrum DFR shows that the interwinding solid insulation contains a typical % moisture (1.7 %) for a service-aged transformer but the liquid insulation reports high conductivity (11.8 pS/m).
- Further internal inspection of the unit revealed that the tank walls and paper insulation retained contamination in areas making it difficult to remove. It was recommended to flush the core coil assembly several times to remove contamination. Samples were taken and sent to the laboratory for analysis.
- It is important to mention that historical DGA data (Figure 10) did not alarm the operator. In the Duval Triangle 1, values fluctuated within T1 and T2 regions. T1 and T2 are part of the six basic types of faults or stresses in transformers, identifiable with the Duval Triangle 1. T1 corresponds to thermal faults < 300 °C, and T2 corresponds to thermal faults between 300 and 700 °C.

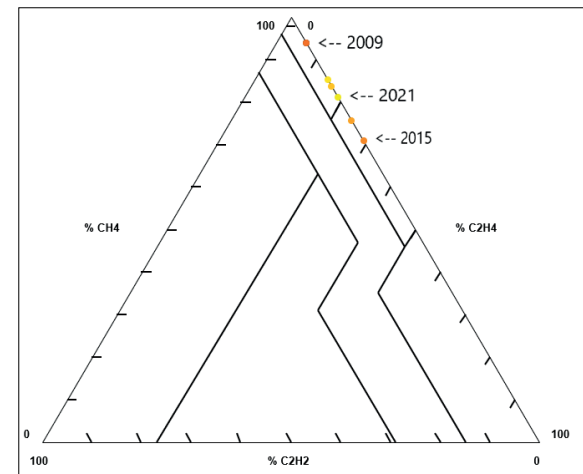
Figure 10: DGA identified fault condition from 2009 to 2021 for the 1978 transformer of this case study
