What is melting here?

CASE STUDY

Time for an SFRA
test

This case study has been generously supplied by the Hitachi Energy Service group in Sweden. A 22 MVA, 10.5 kV/276 V (voltage regulation from 336 to 216 V), Diii furnace transformer, operating in heavy use for many years at a steel melting plant in Europe was subjected to a complete series of tests after a sudden failure during operation. The service contractor evaluated the electrical and dielectric condition of this transformer. During service, this type of transformer has its secondary winding connected externally in a Delta configuration through a high current bridge. To clarify the vector designation, a simple diagram showing its terminals is presented in Figure 1.

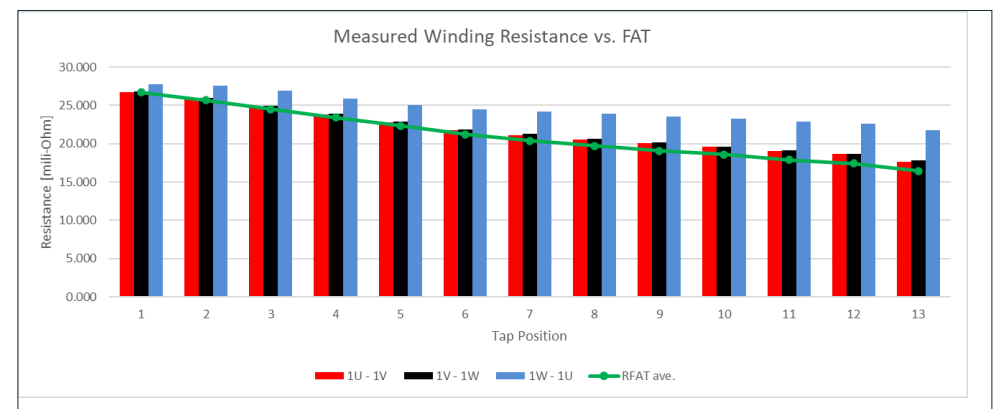
Figure 2: Winding Resistance Measurement corrected to FAT for comparison

- R_s – Resistance at reference temperature T_s
- R_m – Resistance at measured temperature T_m
- T_k – 234.5 °C (copper) and 225 °C (aluminium)
- The results reveal a mess. The Phase C winding resistance is a concern on Tap position 1 and, as the tap position changes and additional portions of the tap (or regulating) winding are added, the results substantially deteriorate further. Phase A and Phase B test results are unacceptable at higher tap positions too. The significant differences observed in this transformer are better visualised in the resistance measurement plot (Figure 2) and the graphed error, given in % (Figure 3).

- The plot in Figure 2 does show an elevated value of winding resistance test results as compared to FAT values but of most significant note is the variation of phase C.

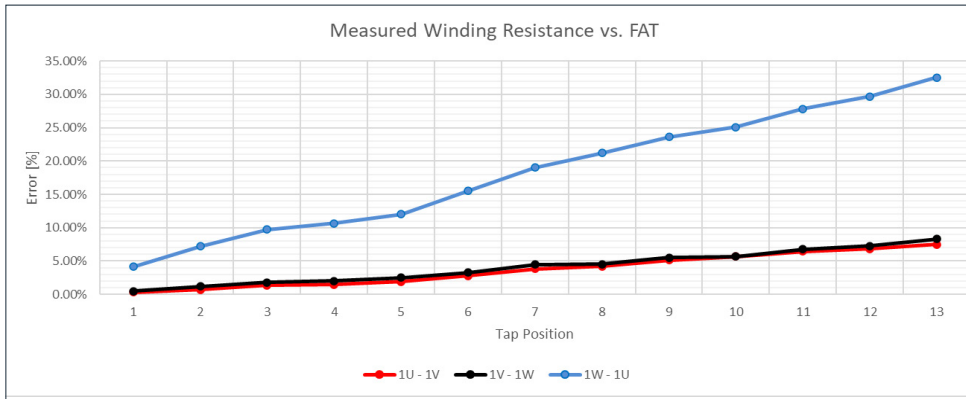
Figure 3: Percentage variation with respect to FAT measurements

- Figure 2 shows that phases A and B behave similarly with increasing variation with respect to FAT measurements as the tap position changes. Taps 9, 10, 11, 12, and 13 would unequivocally be considered for investigation as the difference is > 5 %.
- Phase C behaves quite differently, exceeding acceptable variation on all tap positions.
- Phases A and B were affected by the fault in phase C, as the windings in operation were Delta connected.
- Winding resistance test results on the LV side are presented in Table 3. The table provides test results for one section of the LV winding. The other sections of the LV winding yielded similar results.

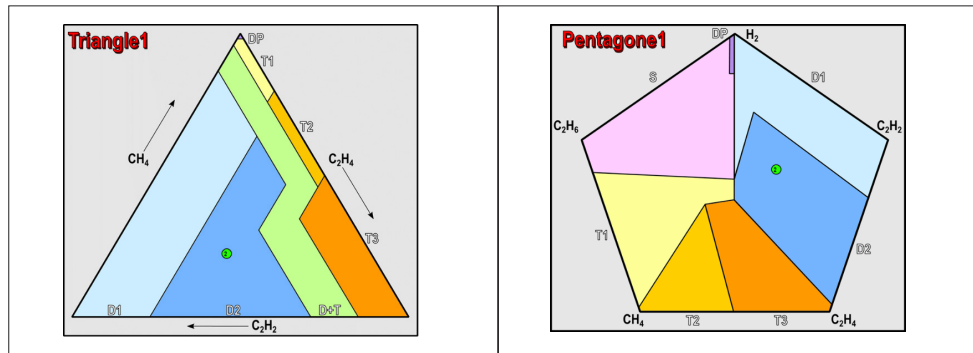
Figure 4: Duval's fault analysis of the oil sample taken after the failure of the transformer

- The post failure DGA analysis indicates a D2 position in Duval's Triangle 1, as well as in Pentagon 1. D2 is an indication of "high energy discharge including arcing. Expected metallic fusion and presence of carbon particles in the oil." These results are presented in Figure 4.

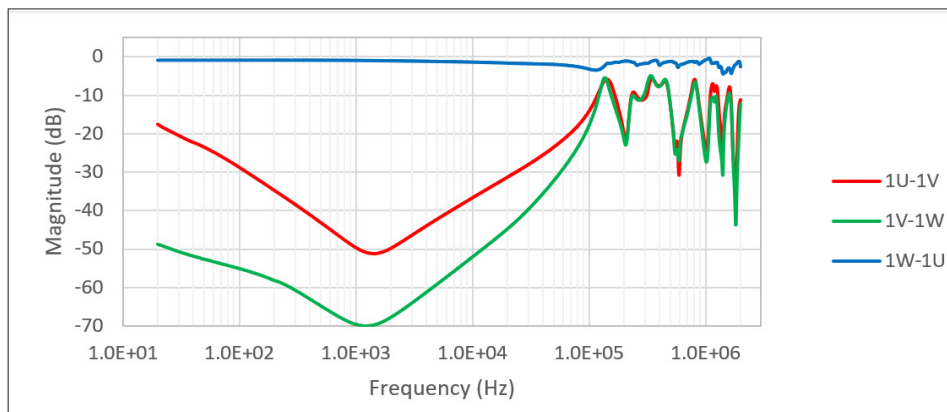
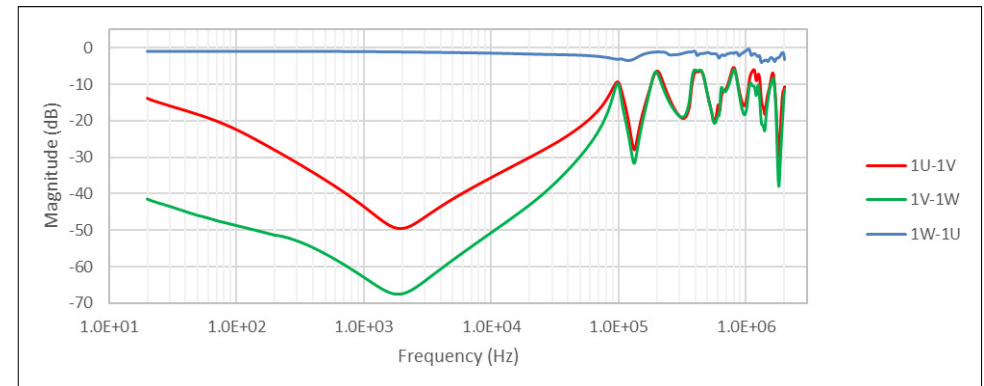
Figure 5: High voltage open circuit – Tap position 1

Figure 6: High voltage open circuit – Tap position 13

- SFRA open circuit test results (Figures 5 and 6) indicate a short circuit in phase C (blue traces). The fault has also affected the other two phases, resulting in a complete asymmetrical response.

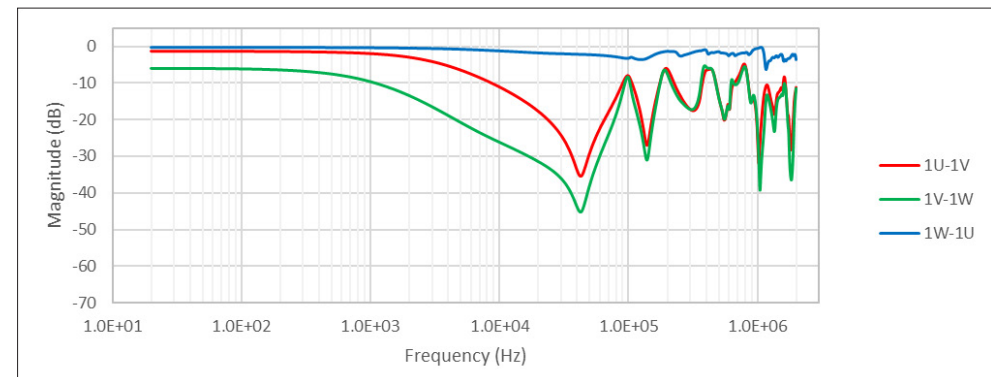
Figure 7: High voltage short circuit test

- SFRA HV short circuit test results confirm that phase C is affected in this transformer but also that this damaged phase affects the response of phases A and B.
- There was no doubt that the transformer required major work before returning it to service. To evaluate the extent of the damage identified by this series of tests, the asset owner ordered an internal inspection.
- During the inspection, the fault was observed on the phase C regulating winding as shown in Figure 8.
- The A and B phase windings, as well as the core, were unharmed.
