Diagnostic Test:

1-500Hz Narrow Band  
Dielectric Frequency Response

## Case Study – Thailand

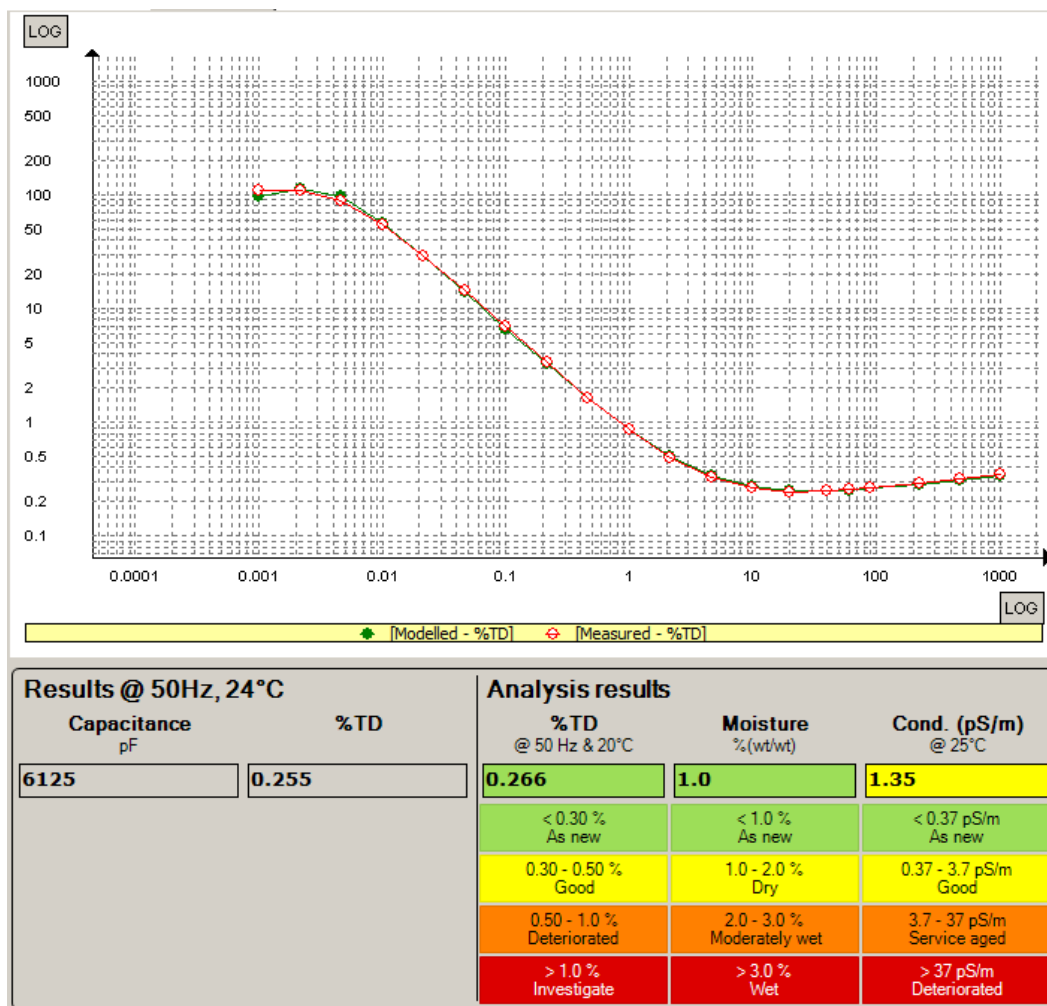
Figure 1 – Example of DFR Curve | IDAX300 | .001Hz – 1000Hz 200V DFR Result & Analysis

The DFR method of testing involves measuring the insulation response at different test frequencies and uses the resultant curve to determine the level of moisture, as well as the presence of impurities. This is done by comparing the curve to a reference (ideal) insulation model curve.

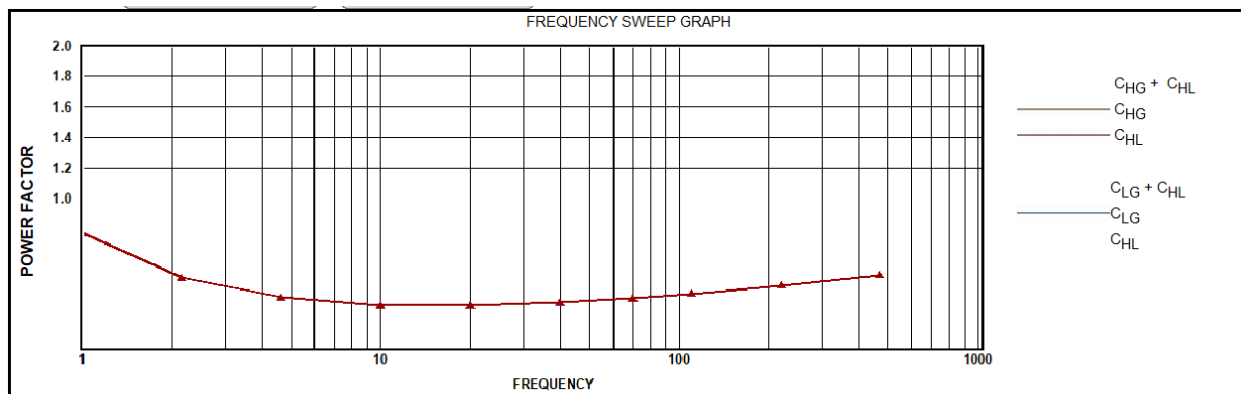
In the figure below, we see the typical shape for a new transformer, (Ch-I) where the curve is considered generally flat. The 60Hz result is 0.34%, the slope around line frequency is slightly positive and the maximum PF at 1 Hz is under 1%. We consider this insulation to be in excellent condition.

Figure 2 – Sample Narrow Band DFR | New Transformer | DELTA4000 | Scaled to max 2% PF

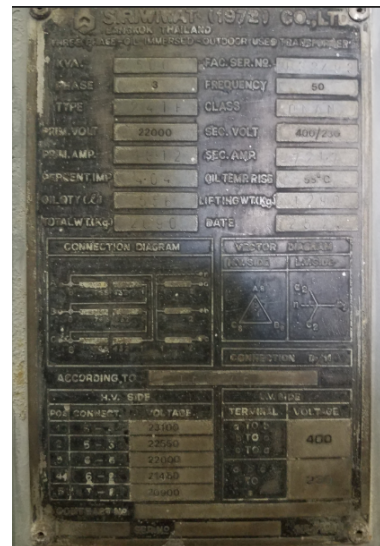
Picture 2

Transformer Nameplate  
Dyn11 – 500kVA  
22kV to 400V

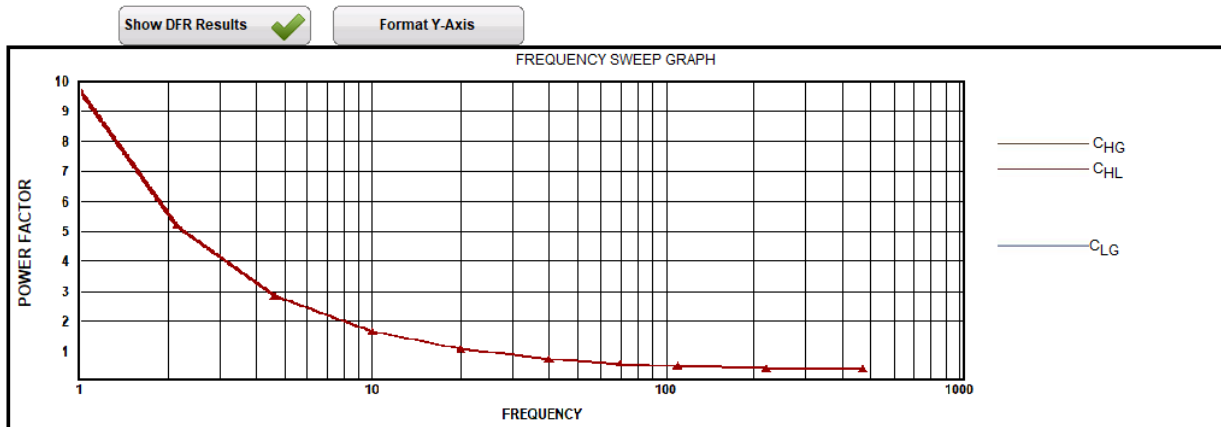
As an additional test to determine the condition of the paper + oil insulation, we were also able to conduct a narrow band DFR test (1-500Hz). Doing so added 7 minutes to the test time, but with no change in lead connections. The narrow band DFR provided us with the following result:

Figure 2 – EGAT – DELTA4000 | 1–500Hz 250V DFR Result | PF @ 50Hz – 0.52%

When observing figures 2 and 3, there is a significant difference in the curve shape even though the 60Hz PF (DF) are within only 0.18%PF of each other. One sees an upward curve in the EGAT transformer where the AEP example transformer shows a virtually flat response.

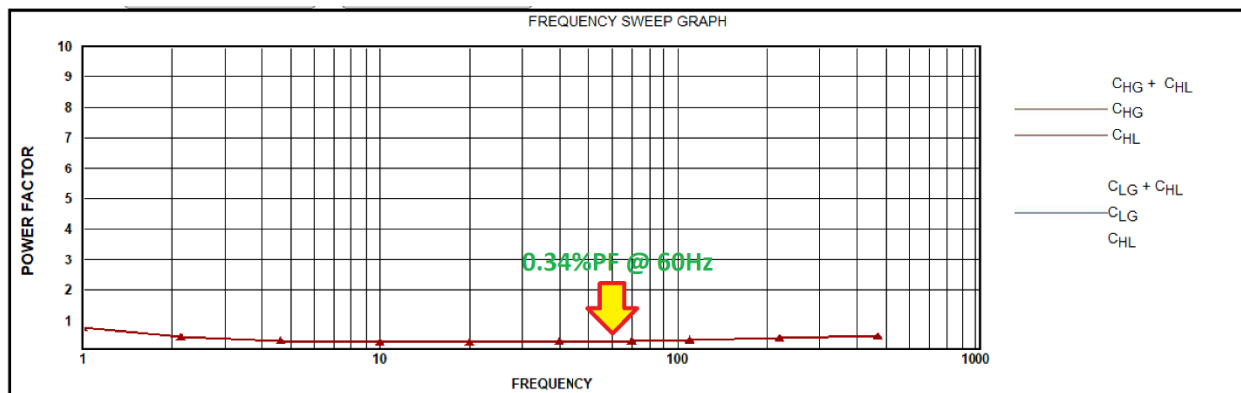
Comparing this result to a typical new transformer using same y-axis scale(0-10%) as above:

Figure 3 – AEP – DELTA4000 | 1-500Hz 250V DFR Result | PF @ 60Hz – 0.34%

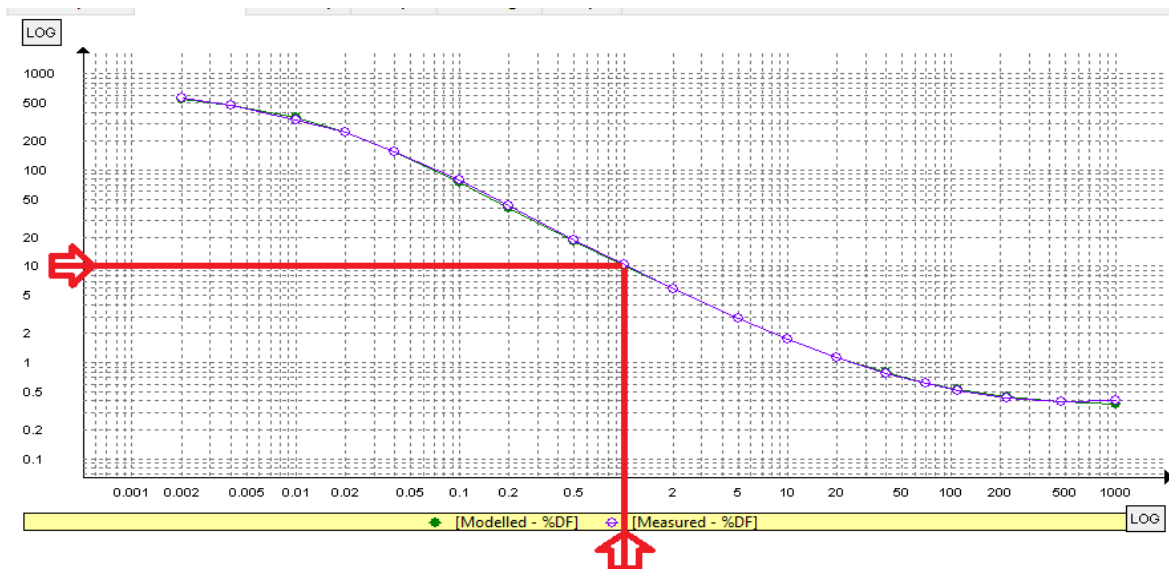
The IDAX result for the EGAT transformer as shown below agrees with the DELTA4000 at 1 Hz, and so both tests are considered reliable and accurate.

**1 Hz - ~ 10%PF - correlates with DELTA4000 result**

Figure 4 – EGAT – IDAX300 Curve | .002Hz – 1000Hz 200V DFR Result

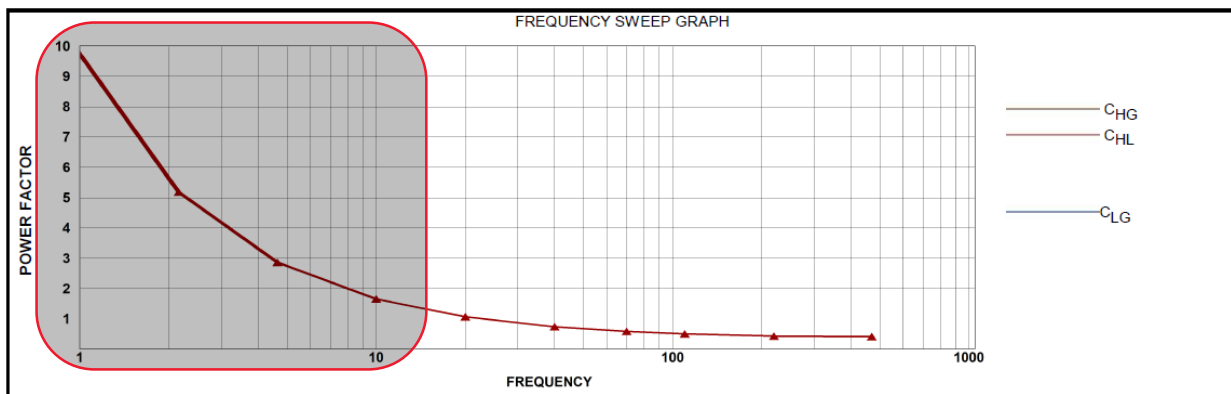
We consider the **1-500 Hz** ability of the DELTA4000 and the TRAX+TDX to be more sensitive to insulation issues versus our competitors because others only offer **15-500Hz** for their narrow band DFR. As shown below, one can see a significant upward curve of results across the 1-15Hz portion, whereas, with only 15-500Hz, this upward curve shape is not as apparent. The difference is observed on the example below versus competitor’s unit:

*Figure 6 - Greyed out area not visible in competitor’s unit. Remaining graph portion appears almost flat.*

With competitor units, we are asked to look for the negative slope of the PF curve around line frequency (60Hz in this example), which is a valid method for determining an issue. This slope is not as easy to detect, and the wider 1-500Hz frequency DFR gives us clear evidence of an issue. Small changes around line frequency (for determination of curve slope) are more difficult to detect than with large changes as seen above. With lower frequency tests (below 15 Hz), we see clear evidence of moisture condition, even if we cannot determine what % moisture content we are at. As skill level is not consistent across different users, the 1-500Hz curve gives a clear indication of issues.

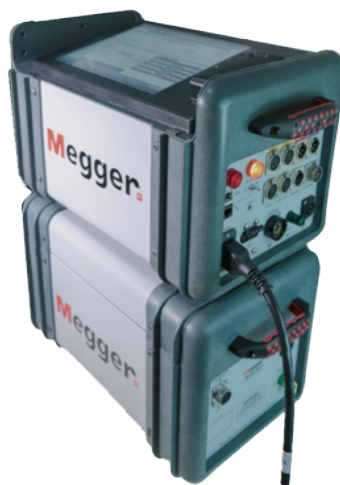
Figure 6 – DELTA 4310A

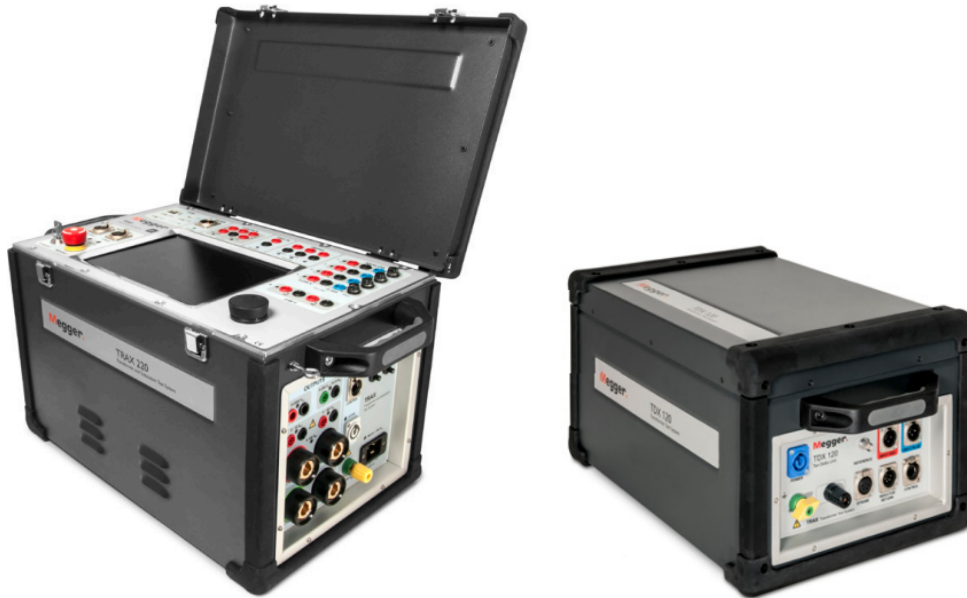
*Figure 7 – TRAX 220 + TDX 120*
