# Reducing failure risk of HV instrument transformers in the transmission system

**CASE STUDY**  
NB DFR on HV CVTs

## – application of narrowband dielectric frequency response (NB DFR) on HV CVTs

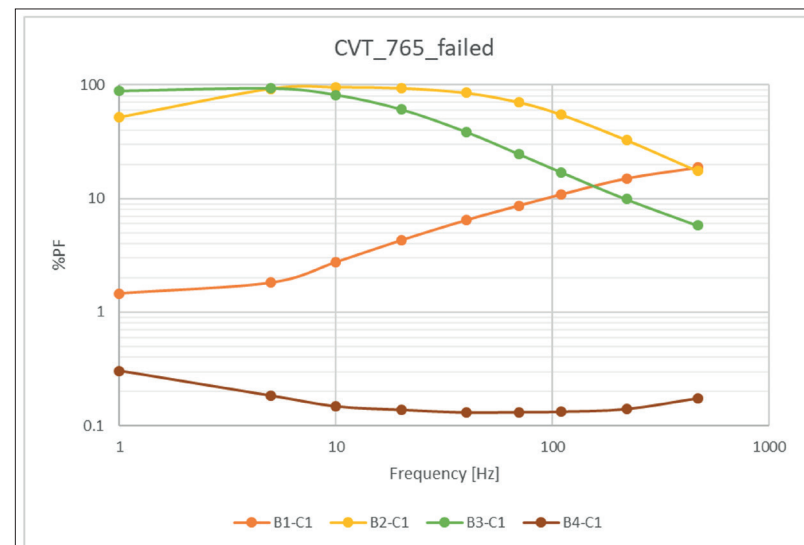
Figure 3: NB DFR plot of failed CVT 1's C1 sections B1 to B4

- For additional insights, 250 V narrowband dielectric frequency response (NB DFR) tests, comprised of PF measurements made between 1 and 500 Hz, were performed on all 4 sections of CVT-1 (Figure 3).
- The customer reported this fairly obvious failure as an over-pressure event and replaced CVT-1 with CVT-1R.
- CVT-1R was similarly tested. Its acceptable capacitance and PF and NB DFR test results (Figures 4 and 5) serve as helpful, normative references for CVT test results.

(Note the % PF at 60 Hz in the 250 V NB DFR test results above; comparing to the 10 kV % PF test results in Figure 1 confirms significant, abnormal voltage dependencies.)

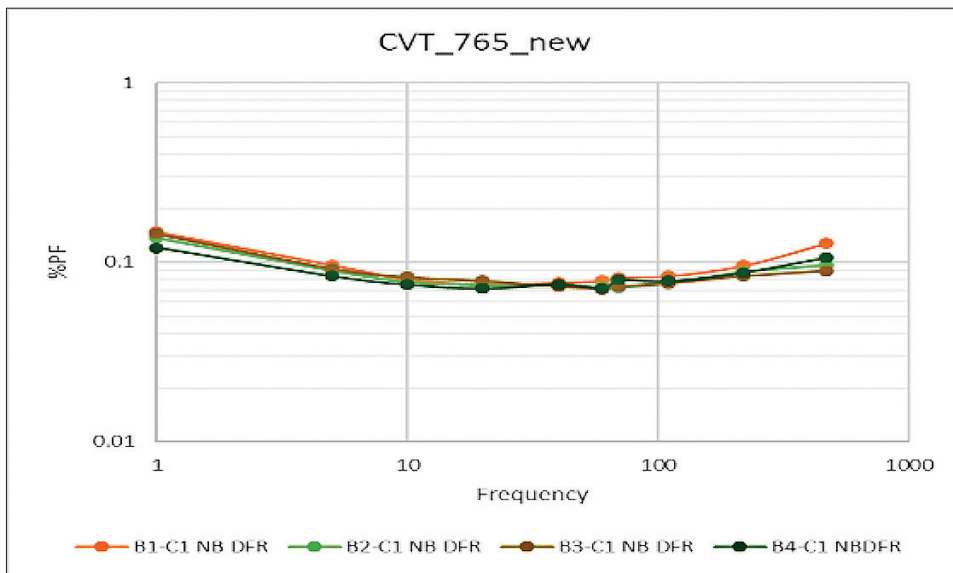
Figure 5: Acceptable NB DFR test results for replacement CVT-1R C1 sections B1 – B4

- A CVT in good condition should have a very low % PF value (at 20°C) <0.2% at 1Hz (Figure 5).
- The utility performs monthly visual inspections but did not notice the oil leak between C1 sections of CVT-2. Testing averted its likely failure.
- NB DFR testing will be incorporated in the utility’s future routine maintenance of CVTs.
- The Megger Delta 4000 and TDX120 provide both basic (capacitance and PF) and advanced (NB DFR) diagnostic insulation testing. Atypical NB DFR results should be further investigated with a full dielectric frequency response (DFR) test using the Megger IDAX 300.

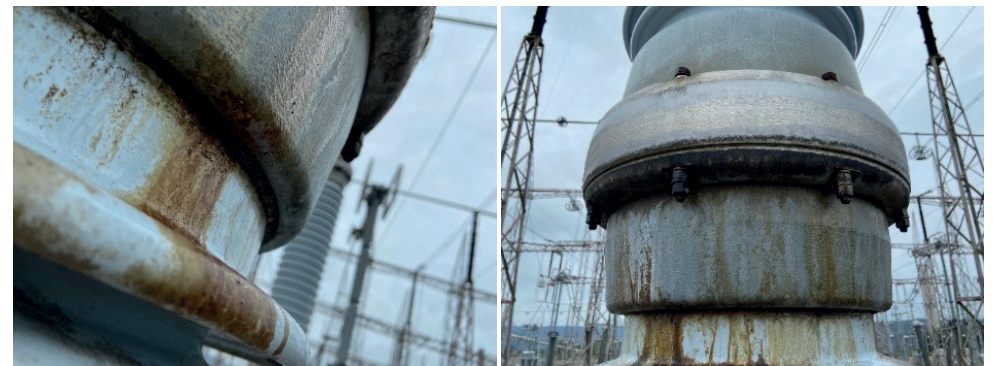
TEST NO	INSULATION TESTED	TEST KV	Test Freq	L(H) CAP.(pF)	POWER FACTOR %			Equivalent @ 10 kV		%VDF
					MEAS.	@ 20°C	CORR.	mA	Watts	
1	B1 C1 cal 28963 +1.88%	10.00	60	29,509.65 pF	0.25			111.2432	2.7362	0.06

Figure 7: C1-B1 section capacitance and PF test results for stained CVT-2

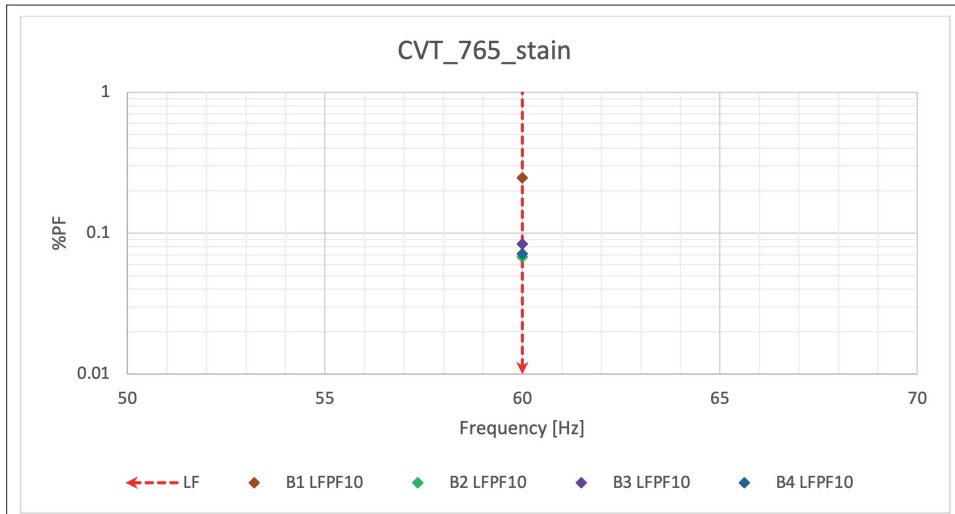
Figure 8: 10kV line frequency % PF test results for C1 sections B1 – B4 of CVT-2  
(Note the elevated % PF for C1-B1 section (0.25%) relative to the other 3 sections (~0.08%.)

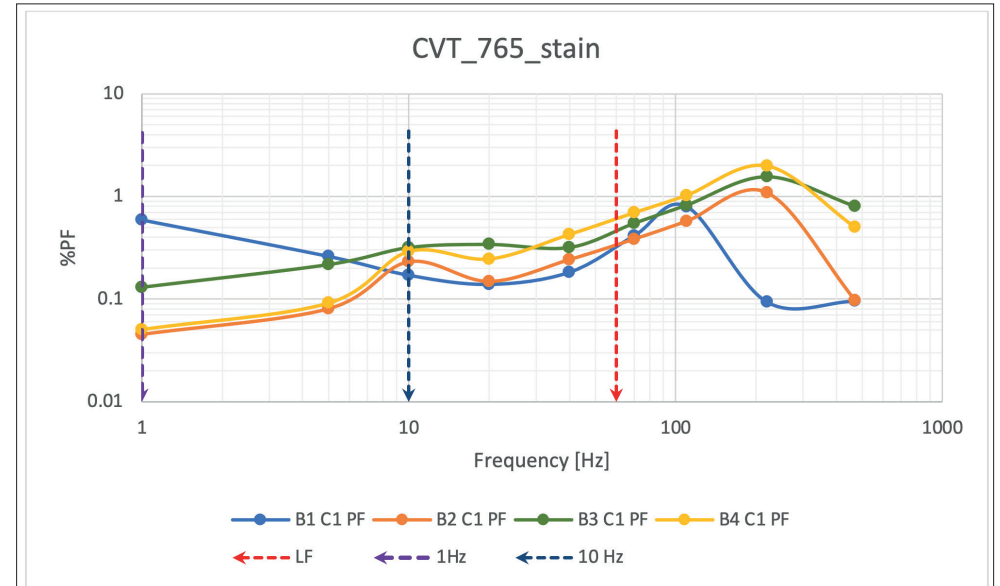
Figure 9: NB DFR test results 1-500Hz on CVT-2  
(Note that all units connected in series have been affected and the dielectric response presents an atypical response for all 4 sections. The 1Hz test result of C1 section B1 revealed a different behavior compared to the other sections and a PF tip-up test, Figure 10, was performed to verify its voltage dependence.)

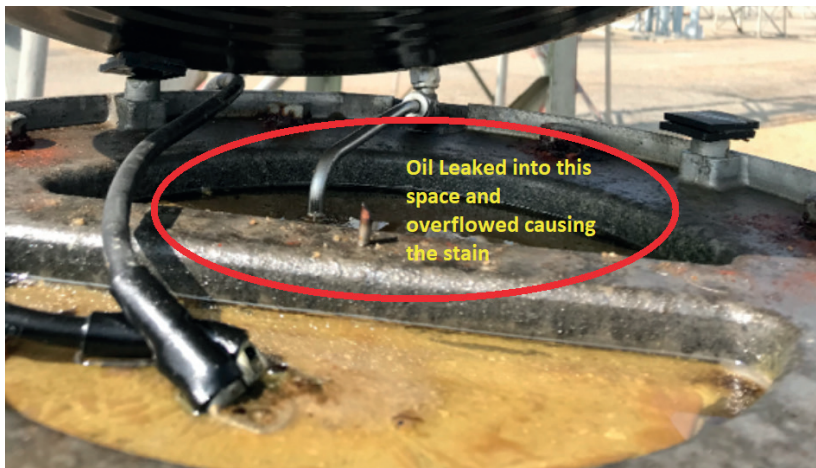
Figure 11: Oil overflow due to puncture on top of C1-B1 section

■ An ensuing teardown of CVT-2 confirmed significant damage to its C1 – B1 section (Figure 11.). Specifically:

- A puncture was found in the C1-B1 section
- Oil was missing from the top portion of C1-B1 section.
- Its insulation integrity was compromised
- Ratio was not affected
- CVT-2 was also replaced.

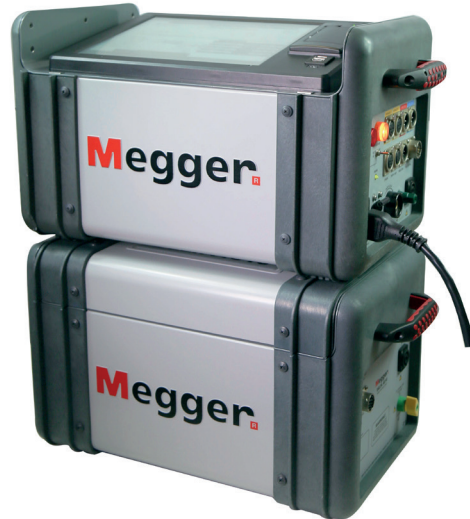
### DELTA:

- Dedicated capacitance and PF/DF test instrument (also exciting current)
- Narrowband DFR (NB DFR: 1 - 500 Hz)
- Individual Temperature Correction (ITC)
- Voltage Dependence Detection (VDD)

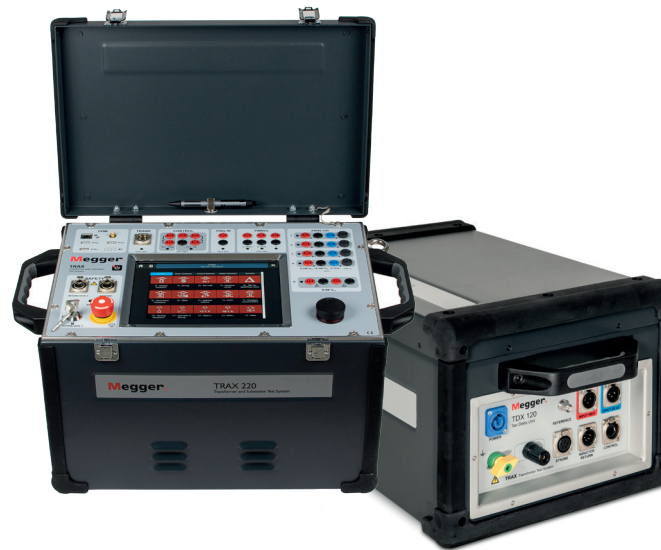
### TRAX + TDX

- A multi-functional tester for transformer and substation equipment
- Narrowband DFR (NB DFR: 1 - 500 Hz)
- Individual Temperature Correction (ITC)
- Voltage Dependence Detection (VDD)

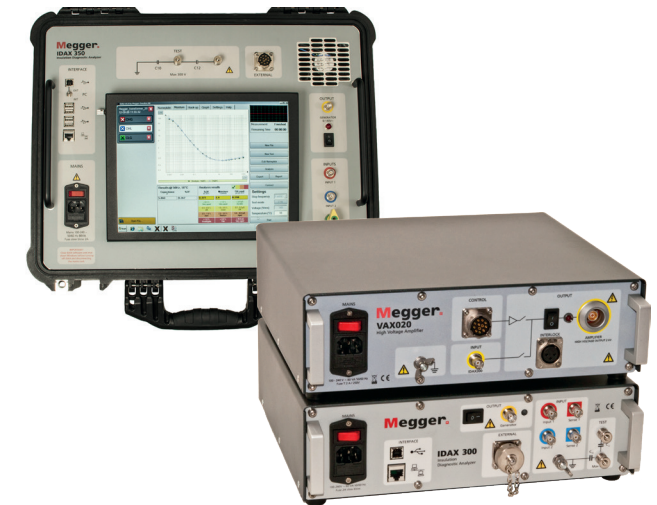
### IDAX + VAX

- Megger's DFR test instrument – analysis of moisture content, PF/DF and oil conductivity
- Fast and reliable in high-interference environments (up to 1.4 kVrms test voltage)
- The result of 20+ years of experience in the design and application of DFR test instruments
- Can also perform transformer dry-out monitoring
