CASE STUDY

Dielectric Assessment for
field commissioning

- A new Dyn1, 16 MVA, 138/13.09 kV transformer manufactured in 2019 arrived at its service destination where a specialized testing crew carried out a complete set of acceptance tests including a 10kV line-frequency (LF) power factor (PF) test. Results were analyzed to determine the transformer's commissioning condition before startup.

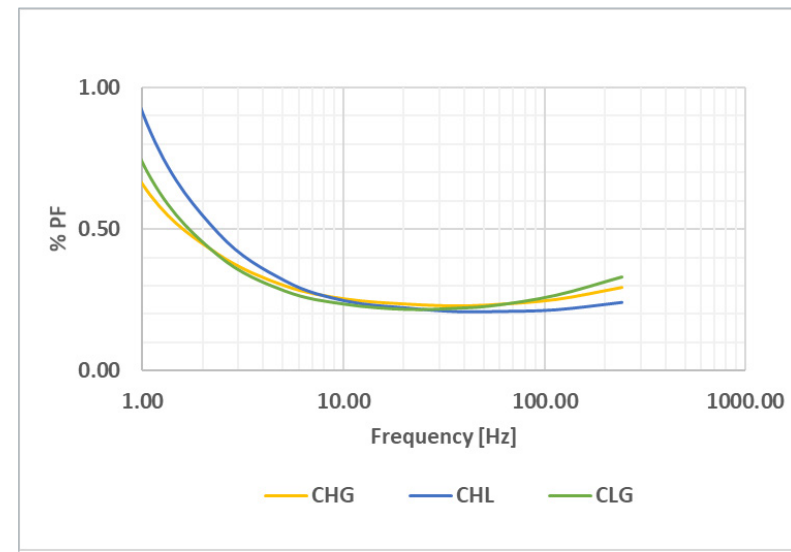
Figure 5: NB DFR winding Insulation corrected to 20 °C by ITC algorithm

- The test results revealed that the overall CHL 1 Hz PF value was elevated when compared to those observed in other new transformers that had just shipped from the factory.
- Given the 1 Hz PF information, the customer performed additional testing, including NB DFR for the overall winding insulation (Figure 5).

- The NB DFR response of the transformer, despite having good PF values at LF and 10 Hz, revealed a significant increase at 1 Hz, which is not expected for a new transformer just shipped from the factory. When the customer submitted the information to us for advice, our suggestion was to run a test that assesses both moisture in the solid insulation and conductivity of the liquid insulation. A full dielectric frequency response test with the Megger IDAX 300 was used.

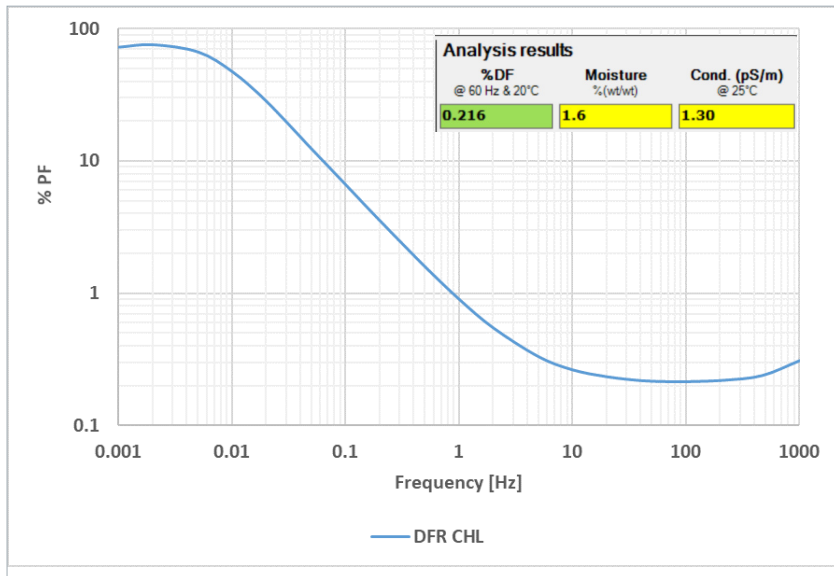
Figure 6: DFR test results obtained with IDAX 300

- The Dielectric Frequency Response (DFR) testing carried out on CHL with IDAX 300 (Figure 6) confirmed a good condition of the overall insulation but not as good as expected for a new transformer during commissioning. For a new unit, it is suggested that the percentage moisture concentration in the solid insulation not exceed 1 % and the conductivity of the liquid insulation (σ) be below 0.37 pS/m.
- As described in CIGRE TB 445 section 5.6.2, moisture in insulation represents a risk to transformers in three ways. It accelerates the aging of paper, reduces the breakdown voltage of oil, and increases the risk of bubbling during a sudden overload or thermal stress. Laboratory experiments reported in CIGRE TB 445 are presented in Figure 7.

- The transformer's owner scheduled a dedicated dry-out process for this unit aiming to reach less than 1 % moisture in the solid insulation following recommendations made by Megger's specialists and CIGRE TB 445.

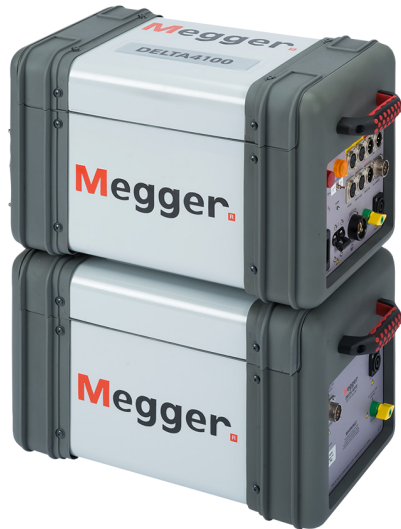
DELTA:

- Dedicated capacitance and PF/DF test instrument (also exciting current):
- Narrowband DFR (NB DFR: 1 - 505 Hz)
- Individual Temperature Correction (ITC)
- Voltage Dependence Detection (VDD)

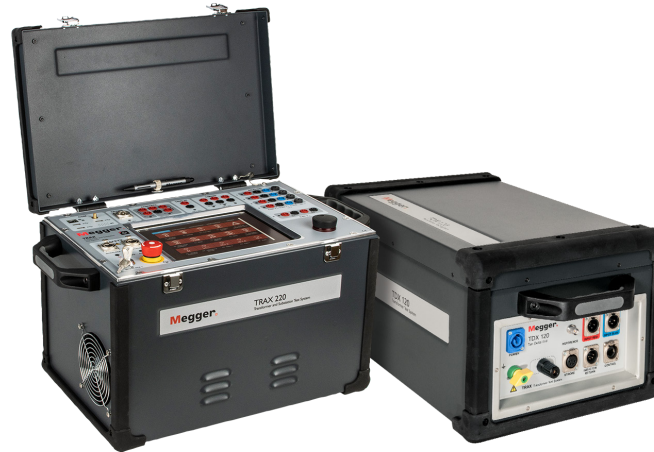
TRAX + TDX

- A multi-functional tester for transformer and substation equipment.
- Narrowband DFR (NB DFR: 1 - 505 Hz)
- Individual Temperature Correction (ITC)
- Voltage Dependence Detection (VDD)

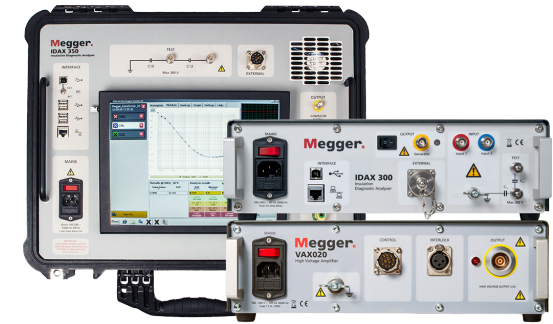
IDAX + VAX

- Megger's DFR test instrument (IDAX) and voltage amplifier (VAX)
- Provides analysis of moisture content, oil conductivity, and PF/DF; also performs NB DFR
- When coupled with the VAX or by upgrading to the IDAX 322, an HV 1.4 kV rms output assures speed and reliability in high-interference environments.
- A culmination of >20 years' experience in the design of DFR test equipment and expertise in the subject area
