Ground fault tracing: CT magnetization

Application Note

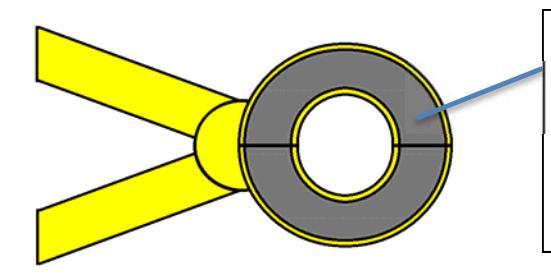
The iron core will have wire wrapped around it in order to transfer an AC signal. However, a DC signal will magnetize the iron core.

When tracing ground faults on ungrounded DC systems, one should not assume that there will be no DC current flowing through the circuit. If a current clamp (CT) is placed on a line with DC current, the DC current will cause the CT, namely its iron core, to magnetize. The higher the DC current, the stronger the magnetization will be. This can make removing the CT quite difficult. The CT can be damaged in the process of removal. In some cases, the CT cannot be removed from the line.

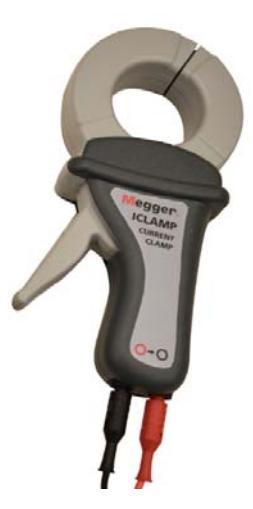
at measuring these low currents used to trace faults. However, this also makes such a core more susceptible to magnetization. The MGFL100 CT is very sensitive but will not have any significant magnetization. This is because the core is made of a mu-metal compound. This core maintains high permeability but is far less prone to magnetization. If it is placed on an energised DC line, it can still easily be removed without any damage.

When tracing low level AC signals or pulses, the larger and purer the CT core, the higher its permeability and the more sensitive the CT will be. This makes the CT better

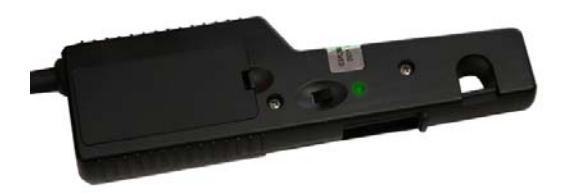
The mini active CT for the MGFL100 uses a flux gate technology, allowing a gap in the core. This also greatly reduces magnetization effects.

Using these current clamps will eliminate magnetization issues due to DC current.
